DEPARTMENT OF TRANSPORTATION

Contract #: 04-0120F4Cty: SF/ALA Rte: 80 PM: 13.2/13.9File #: 69.28**WELDING INSPECTION REPORT****Resident Engineer:**Pursell, Gary**Address:** 333 Burma Road**City:** Oakland, CA 94607**Report No:** WIR-015208**Date Inspected:** 15-Jun-2010**Project Name:** SAS Superstructure**OSM Arrival Time:** 700**Prime Contractor:** American Bridge/Fluor Enterprises, a JV**OSM Departure Time:** 1900**Contractor:** Zhenhua Port Machinery Company, Ltd (ZPMC), Changxing Island **Location:** Shanghai, China**CWI Name:** Mr. Xu Tao / Mr. Li Yan Hua**CWI Present:** Yes No**Inspected CWI report:** Yes No N/A**Rod Oven in Use:** Yes No N/A**Electrode to specification:** Yes No N/A**Weld Procedures Followed:** Yes No N/A**Qualified Welders:** Yes No N/A**Verified Joint Fit-up:** Yes No N/A**Approved Drawings:** Yes No N/A**Approved WPS:** Yes No N/A**Delayed / Cancelled:** Yes No N/A**Bridge No:** 34-0006**Component:** Orthotropic Box Girder(OBG)/TOWER**Summary of Items Observed:**

WELDING INSPECTION REPORT

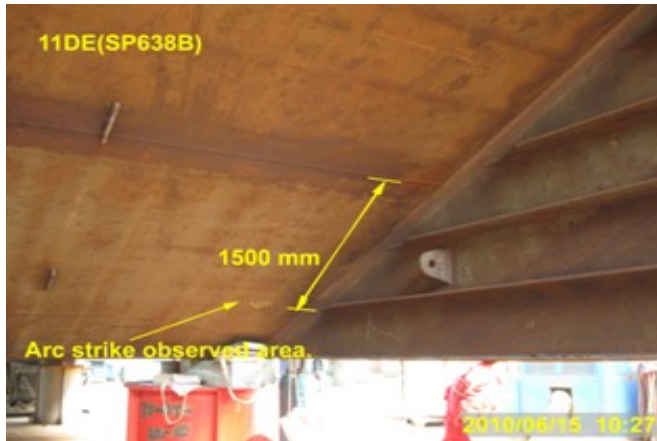
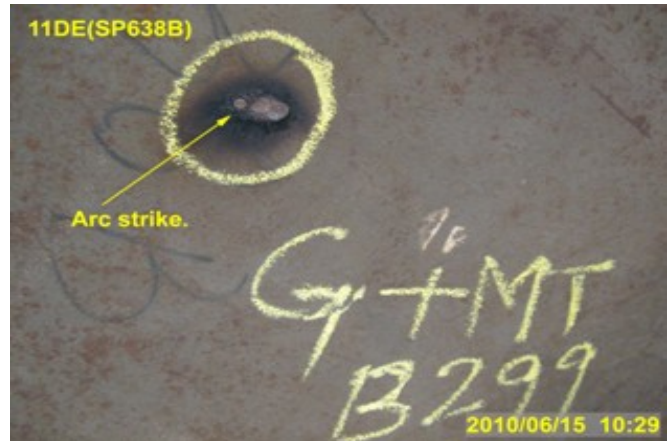
Segment: 11DE-FL3 Location.

During random in process Visual Inspection this QA Inspector observed 1 (one) Arc strike on the Side plate number identified as SP638B near to the weld No: SEG072A-017. The "Y" location is approximately 1500 mm from the weld toe. This QA informed to ZPMC Quality Control (QC) identified as Mr. Li Ping of the above issue, As per ZPMC QC the arc strike shall be repaired and perform Magnetic Particle Testing (MT) for verifying no more defects.

Refer attached photos for additional details.
